**Report on
PPG Industries
Nexus to Lower
Passaic River Study
Area**

September 9, 2016
PPG
Project No. 16692.00/001

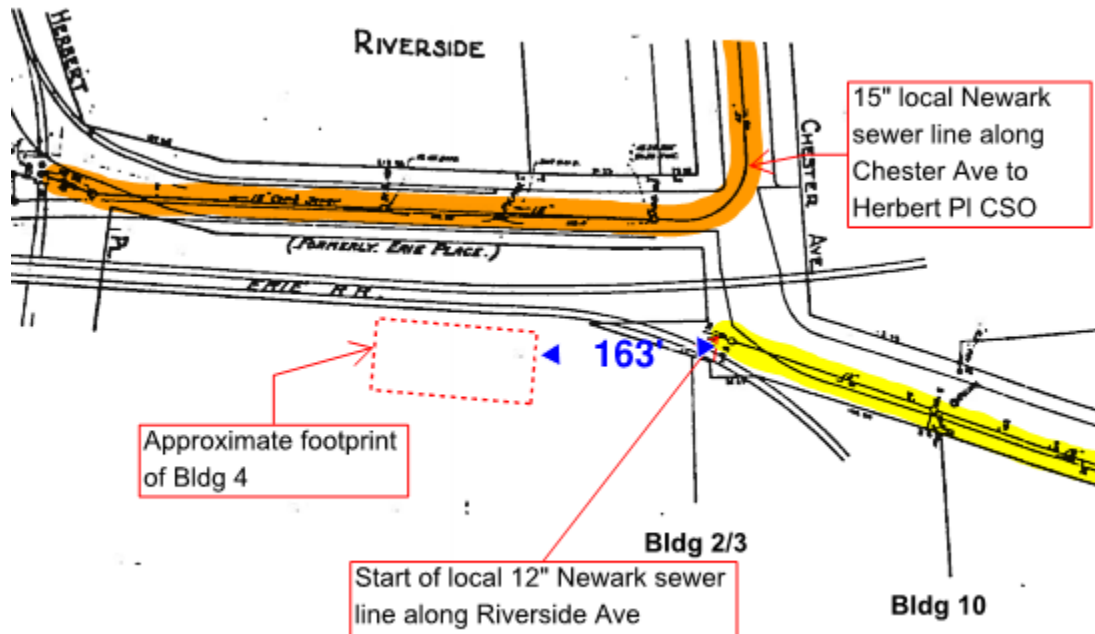
As shown on a historical figure (Appendix B, Attachment 1), the Riverside Avenue area was connected to the local Newark sewer system which was operational as early as 1854 (Modica, 2007). Based upon a 1902 plumber specification document (Appendix C) for Building 4 (five-story manufacturing building), sewer piping is described as being connected to an existing sewer pipe. The specification lists the existing sewer system being 163 feet from the northwest building corner. This distance matches very closely to the beginning of the Delavan pipe connection on the PVSC drawing as show below:

As noted above, Building 4 is connected to the local Newark sewer. It is likely that other pre-1924 buildings would also connect to the local sewer system near the northwest corner of Building 2.

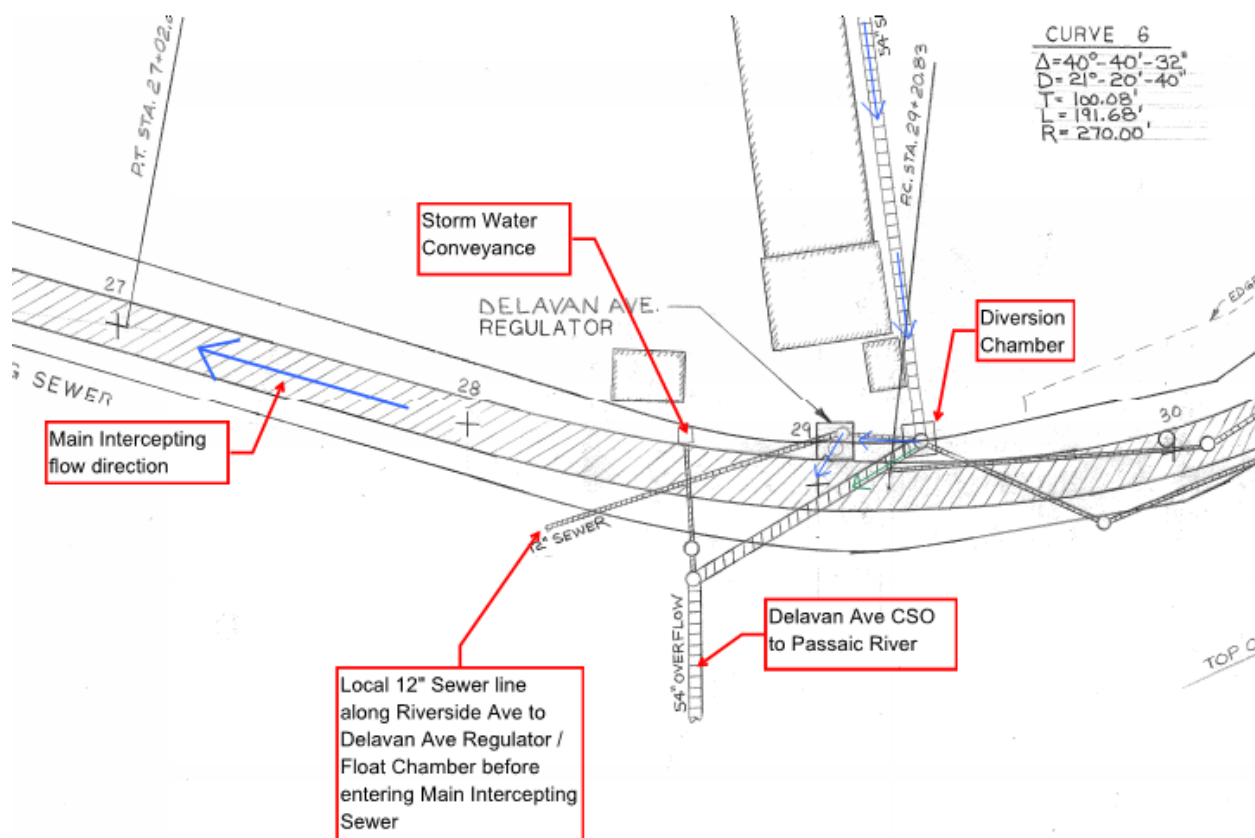
Based upon PVSC Drawing Section 8N, the 12-inch pipe from NCF/RIP connects to the Delavan Avenue regulator chamber (Appendix B, Attachment 3/3a). The connection of the NCF/RIP sewer pipe to this chamber prevents NCF/RIP waste water from being discharged to the river during high flow or bypass events at the Delavan Avenue CSO connection. Instead, NCF/RIP waste water enters the regulator chamber and flows into the main PVSC intercepting sewer and to the PVSC treatment plant. During high-flow conditions, this waste water cannot reach the diversion chamber where the bypass flow to the river occurs. Below is a portion of the PVSC drawing showing the 12-inch sewer from RIP connected to the regulator chamber that is connected directly to the PVSC main intercepting sewer.

Appendix B, Attachments 10 and 11 show current sewers associated with Ardmore Chemical, which shows the same pipe connection beneath Riverside Avenue as during PPG operations.

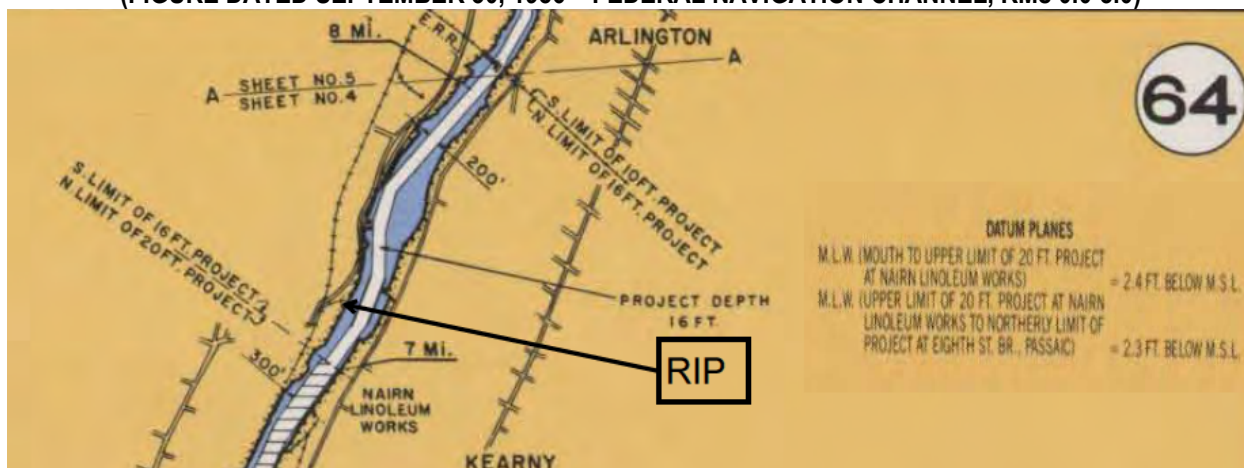
EXCERPT OF FIGURE 1A – USACE JULY 2010
(FIGURE DATED SEPTEMBER 30, 1986 – FEDERAL NAVIGATION CHANNEL, RMs 0.0-8.0)

It is noted that the starting point for distance measurements to points upstream in the Passaic River used by the USACE (Junction Light in the Newark Bay Turning Basin) differs from that used for purposes of the FFS (Louis Berger, 2014). The FFS measurements begin approximately 0.25 mile further north in Newark Bay than the USACE measurements. Accordingly, RM measurements from the FFS and ROD will be approximately 0.25 mile less than those using the USACE starting point. As an example, RM 7.0 using the USACE starting point would correspond to approximately RM 6.75 using the FFS ROD starting point. Because the RIP is very close to the border between the Kearny Reach and Arlington Reach (as defined by the USACE as RM 7.2), there is a discrepancy between the FFS/ROD and USACE in the assignment of the appropriate reach (Arlington Reach) to the RIP.

From the USACE report (July 2010), the Lower Passaic River has been deepened between RM 0.0 and RM 15.4 (Wallington, New Jersey) as a result of several federally authorized projects to promote commercial navigation. Woodard & Curran focused on the Kearny and Arlington Reaches.

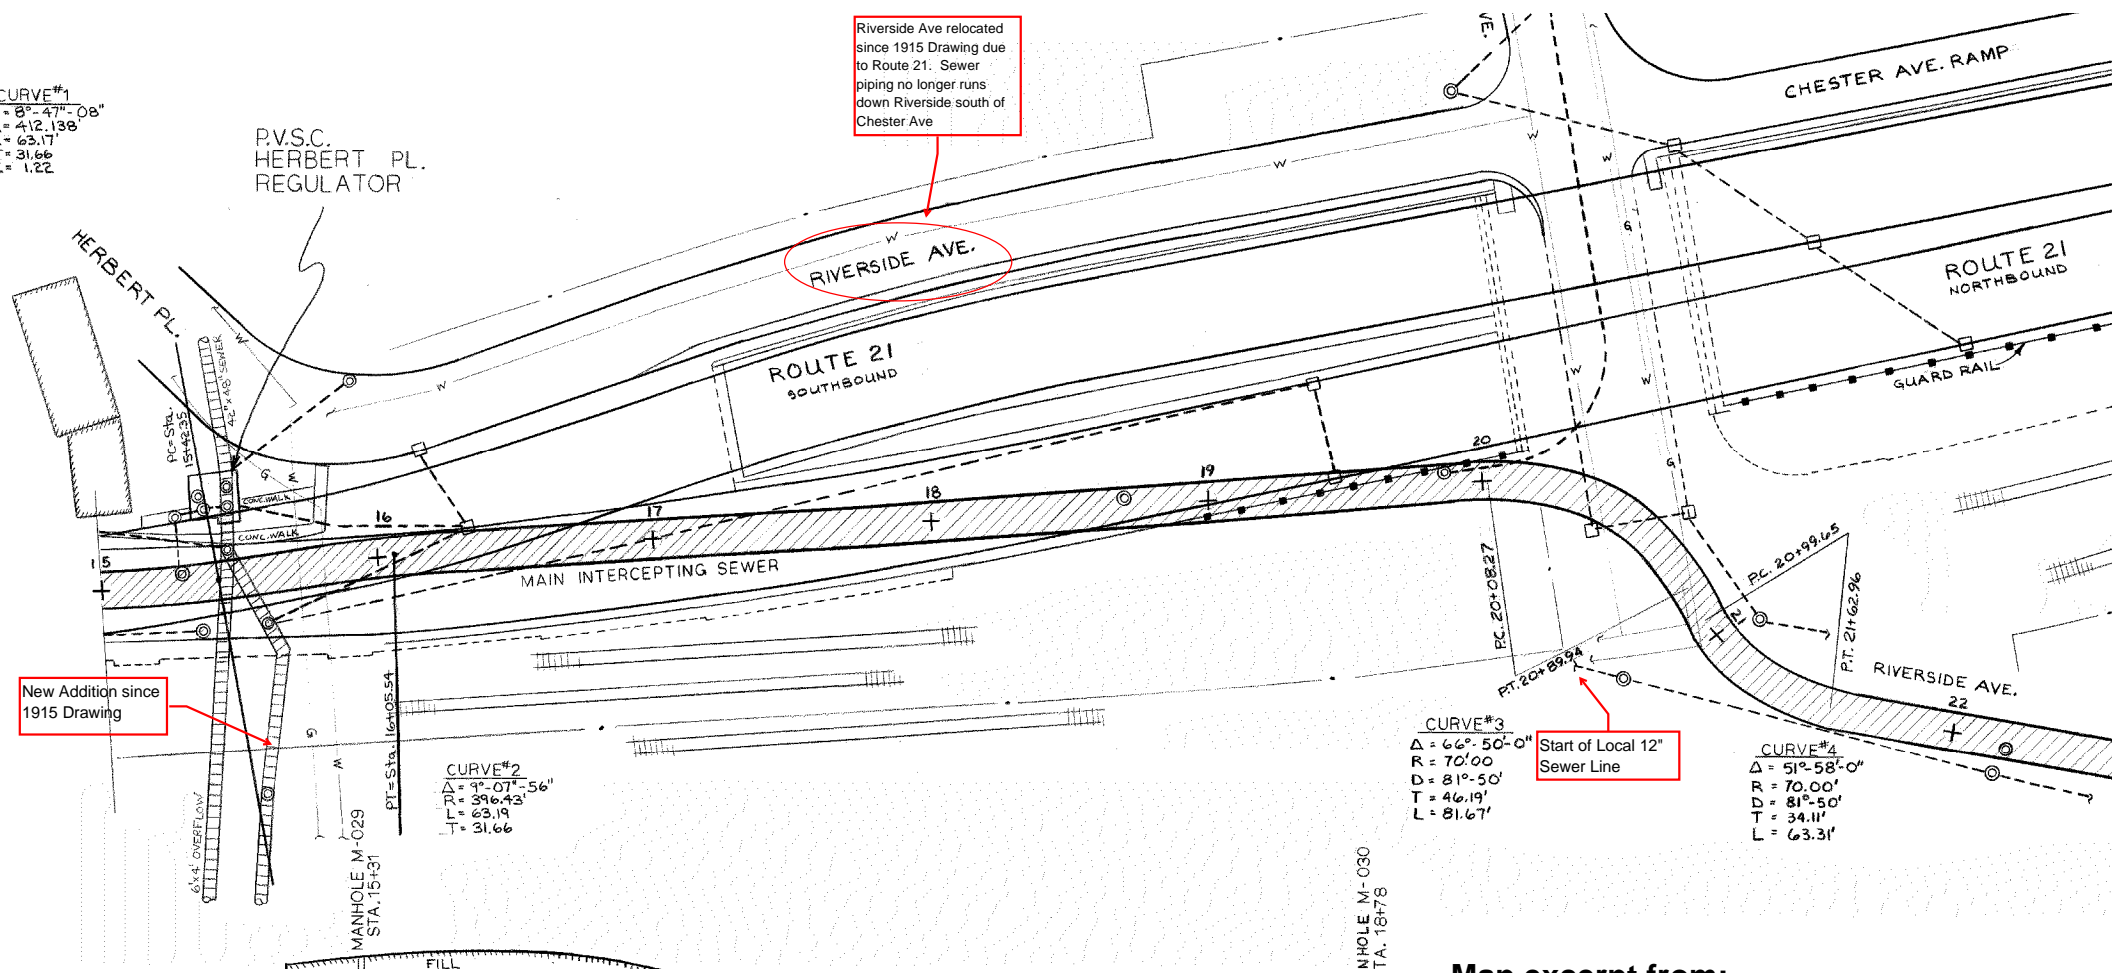
PASSAIC VALLEY SEWERAGE COMMISSIONERS		
SCALE: AS NOTED	APPROVED BY:	DRAWN BY
DATE:		REVISED
MAIN INTERCEPTER- NEWARK		
SECTION - 8N		DRAWING NUMBER MI-28

Map excerpt from:

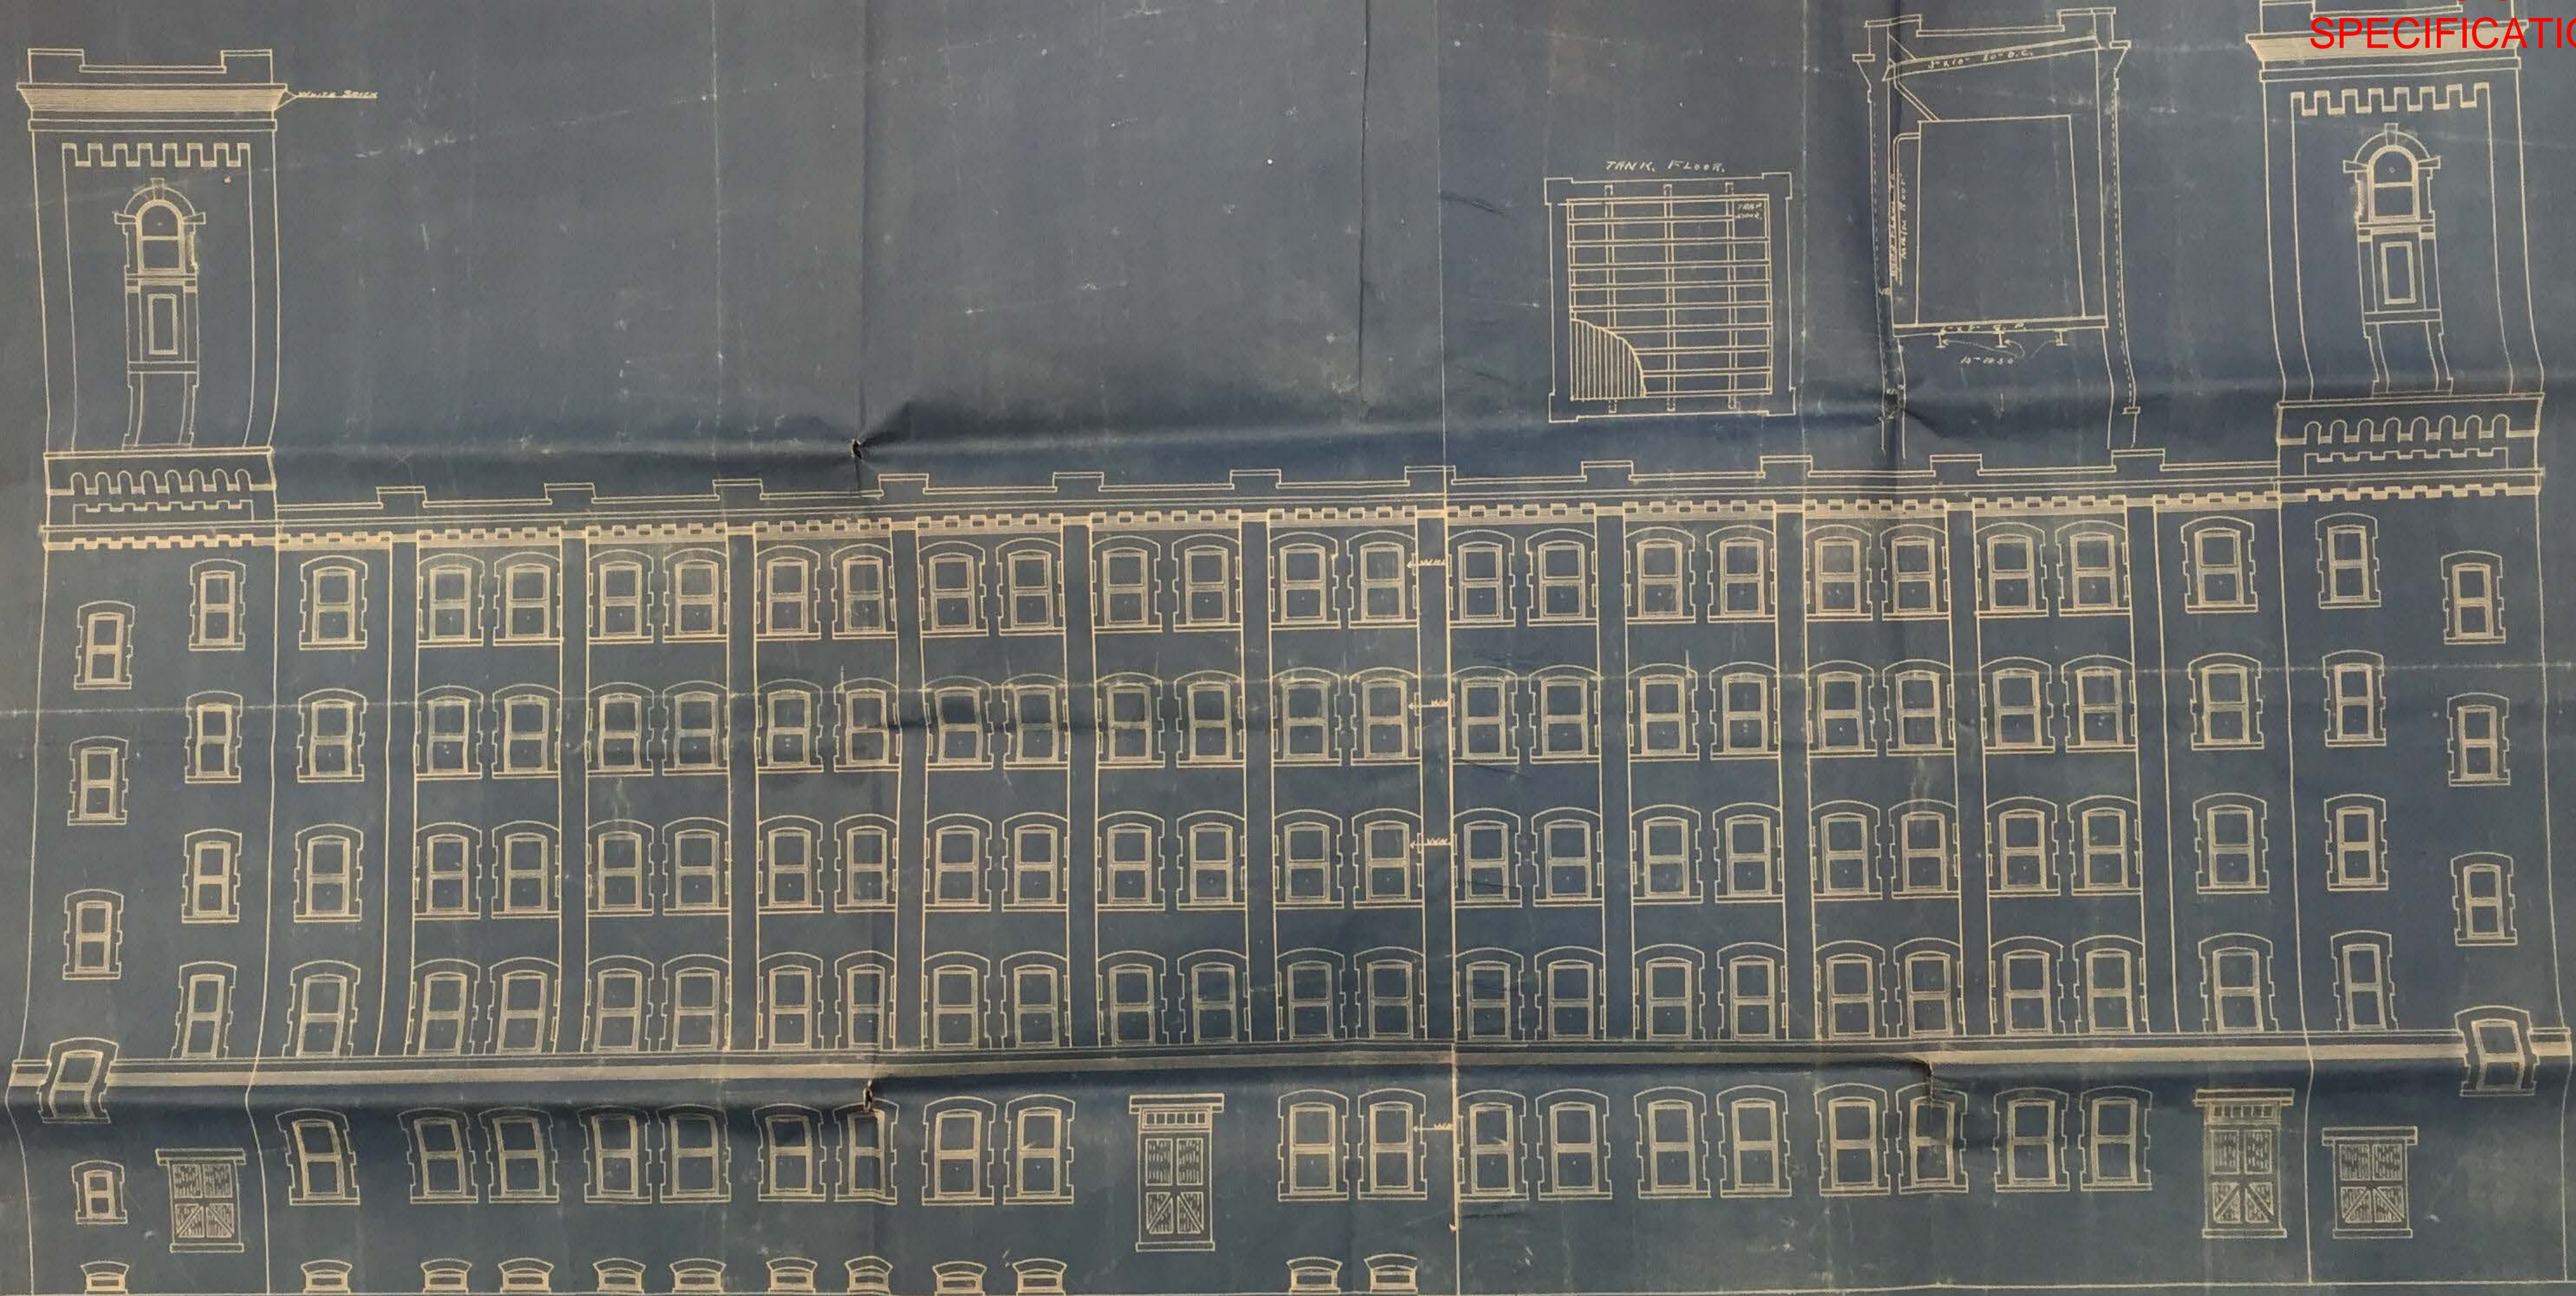
SIDE ELEVATION
FACTORY FOR THE PATTON PAINT CO.
NEWARK
N.J.

Extention to factory building,
for the Patton Paint Co.-
Newark, N.J.

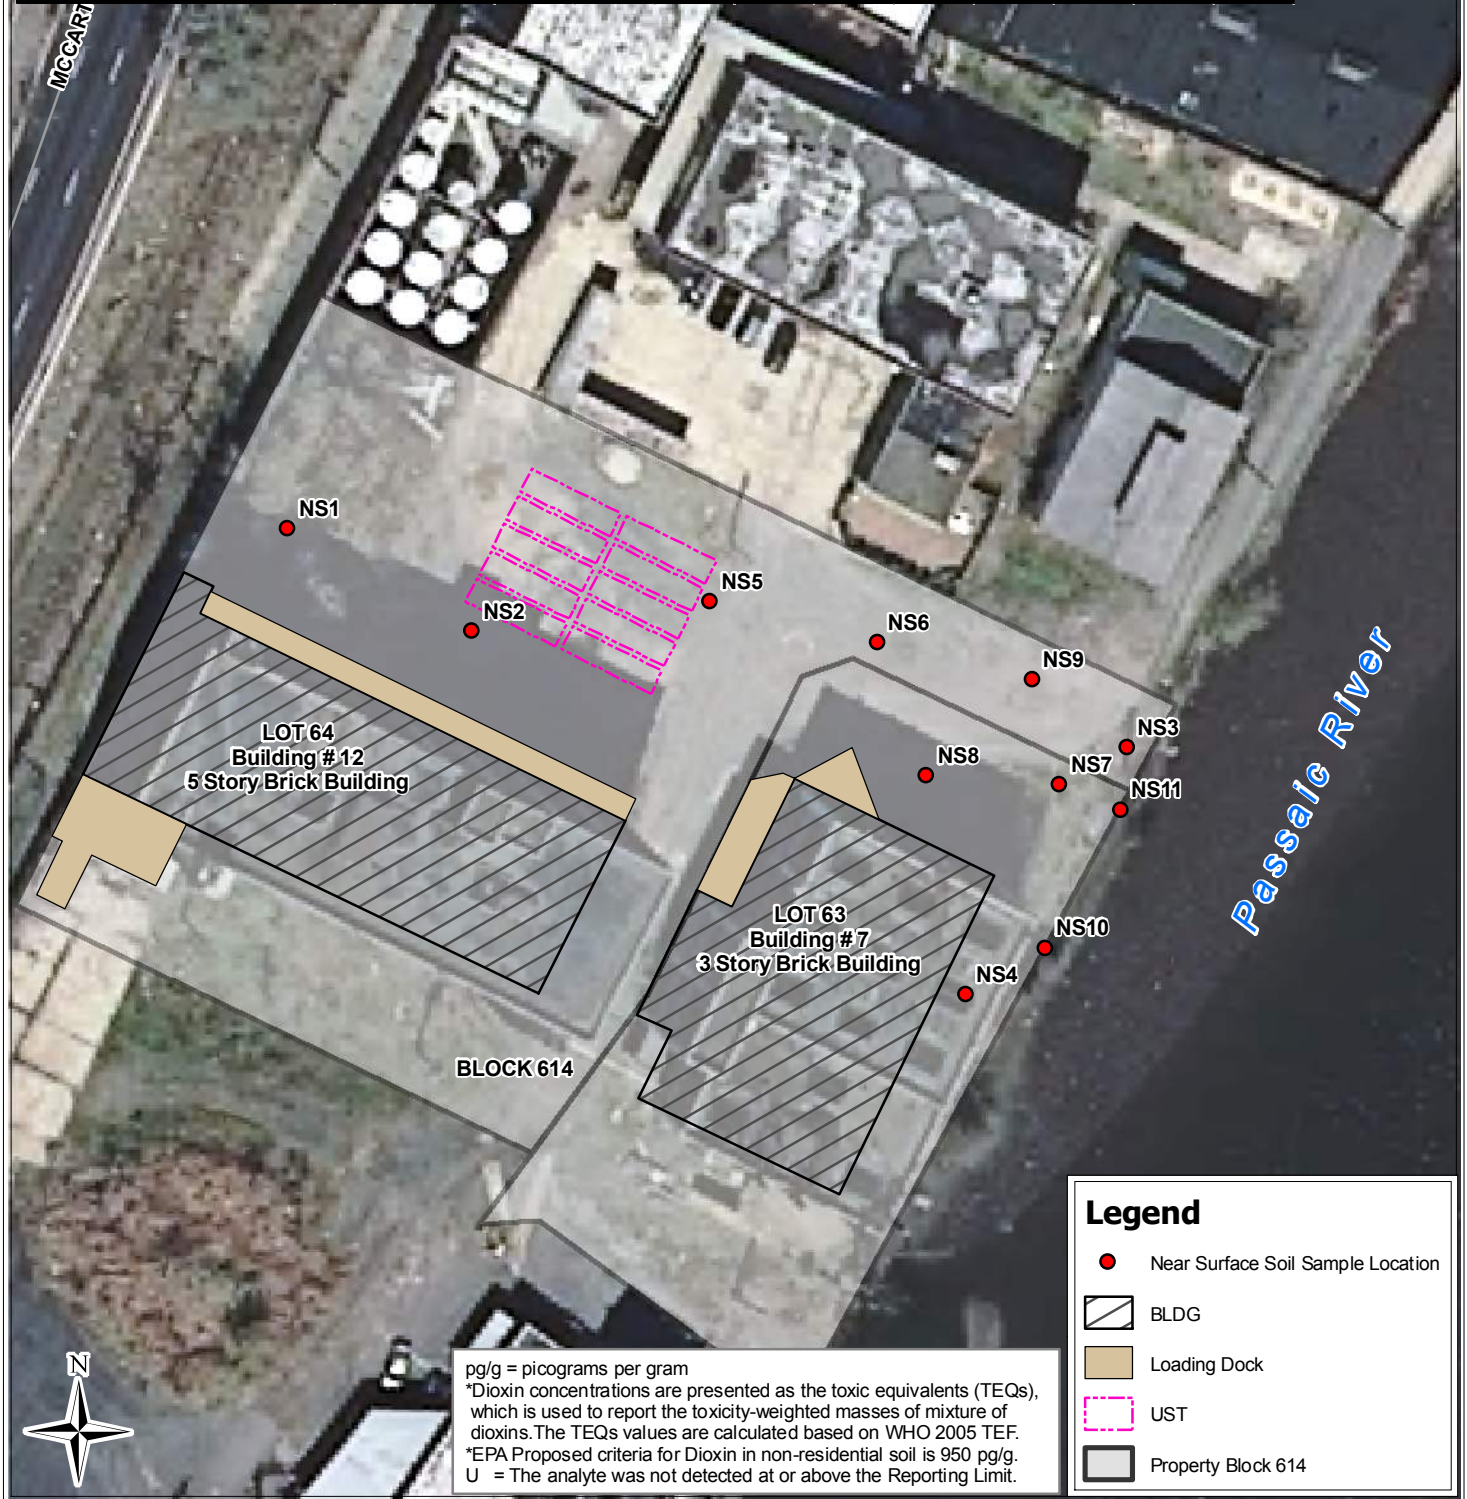
Figure 2
 Dioxin & PCB Results in Soil
 29 Riverside Ave. (Phase 2 Assessment)
 Newark, New Jersey

Map created using 2007 orthoimagery from NJGIN, site survey GPS data, sample results data.

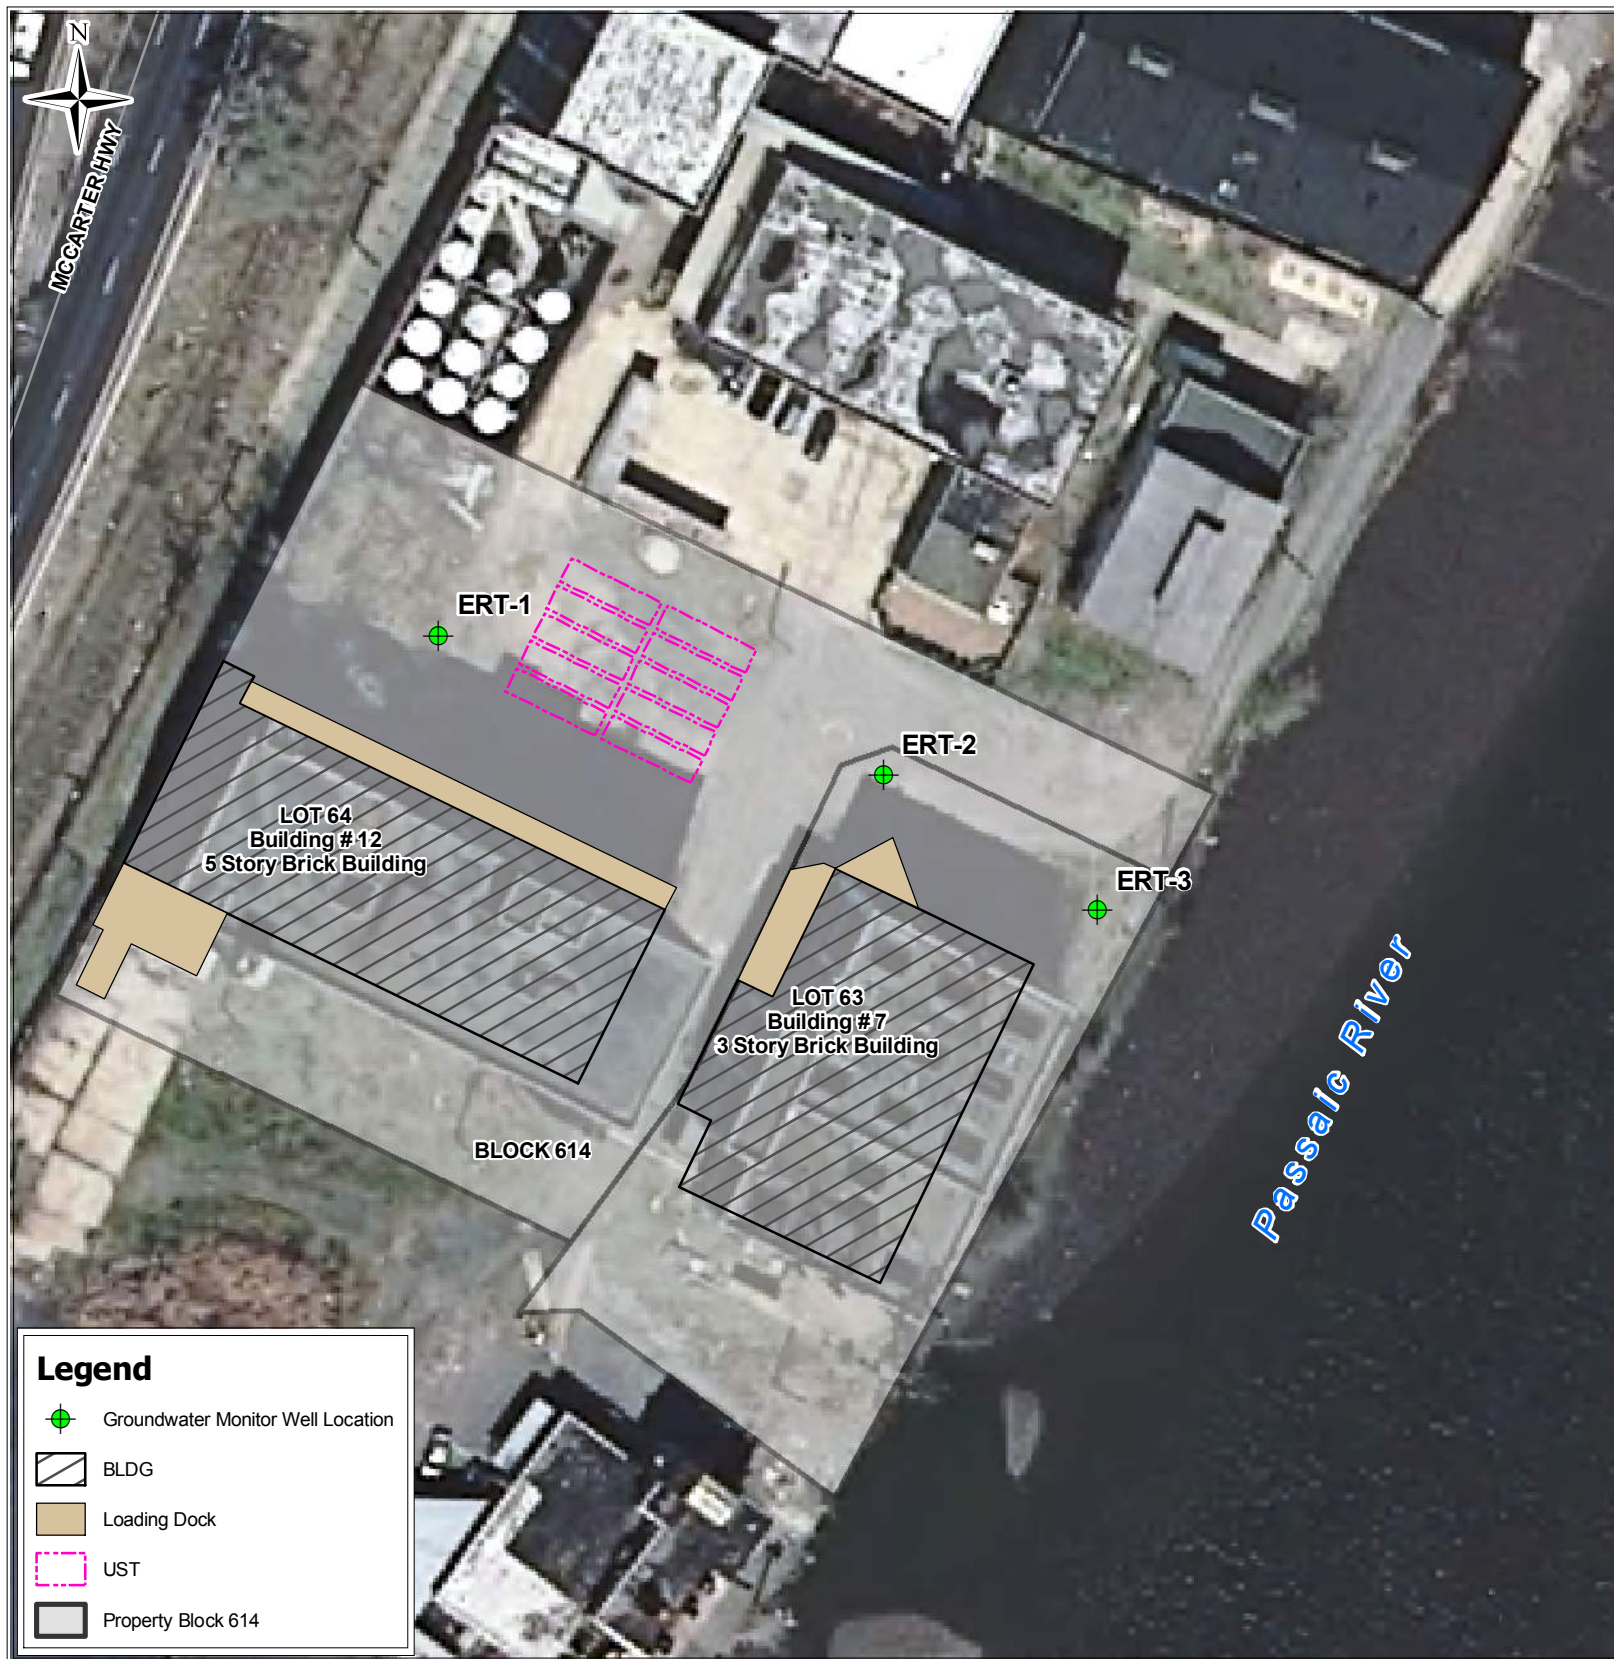
The PCB analyses indicate that one soil sample exceeded the NJDEP Non-residential Direct Contact Soil Cleanup Criteria (NRDCSCC) of 2 mg/kg. Sample NS-1, collected from the top of the soil pile, contained 3 mg/kg of Aroclor 1254 (Table 2). These results, along with the dioxin results, are provided on Figure 2.

On April 12, 2011, 11 surface soil samples (NS-1 through NS-11) and a duplicate NS-7D were collected from the north side of the Site (Figure 2). Samples were collected from the top inch of soil, homogenized, and placed in sample jars. Soil sample locations were selected based on historical information and observations at the Site. The samples were analyzed for PCBs and Dioxin.

Surficial soil samples were collected from various locations throughout the open area on the northern side of the site (Figure 2). One sample was collected from the top of a soil pile near the western boundary of the Site, and two soil samples were collected along the bank of the Passaic River. All soil samples contained most or all of the compounds included in the dioxin analyses. Aroclor 1254 was the only component of the PCB analyses that was present.

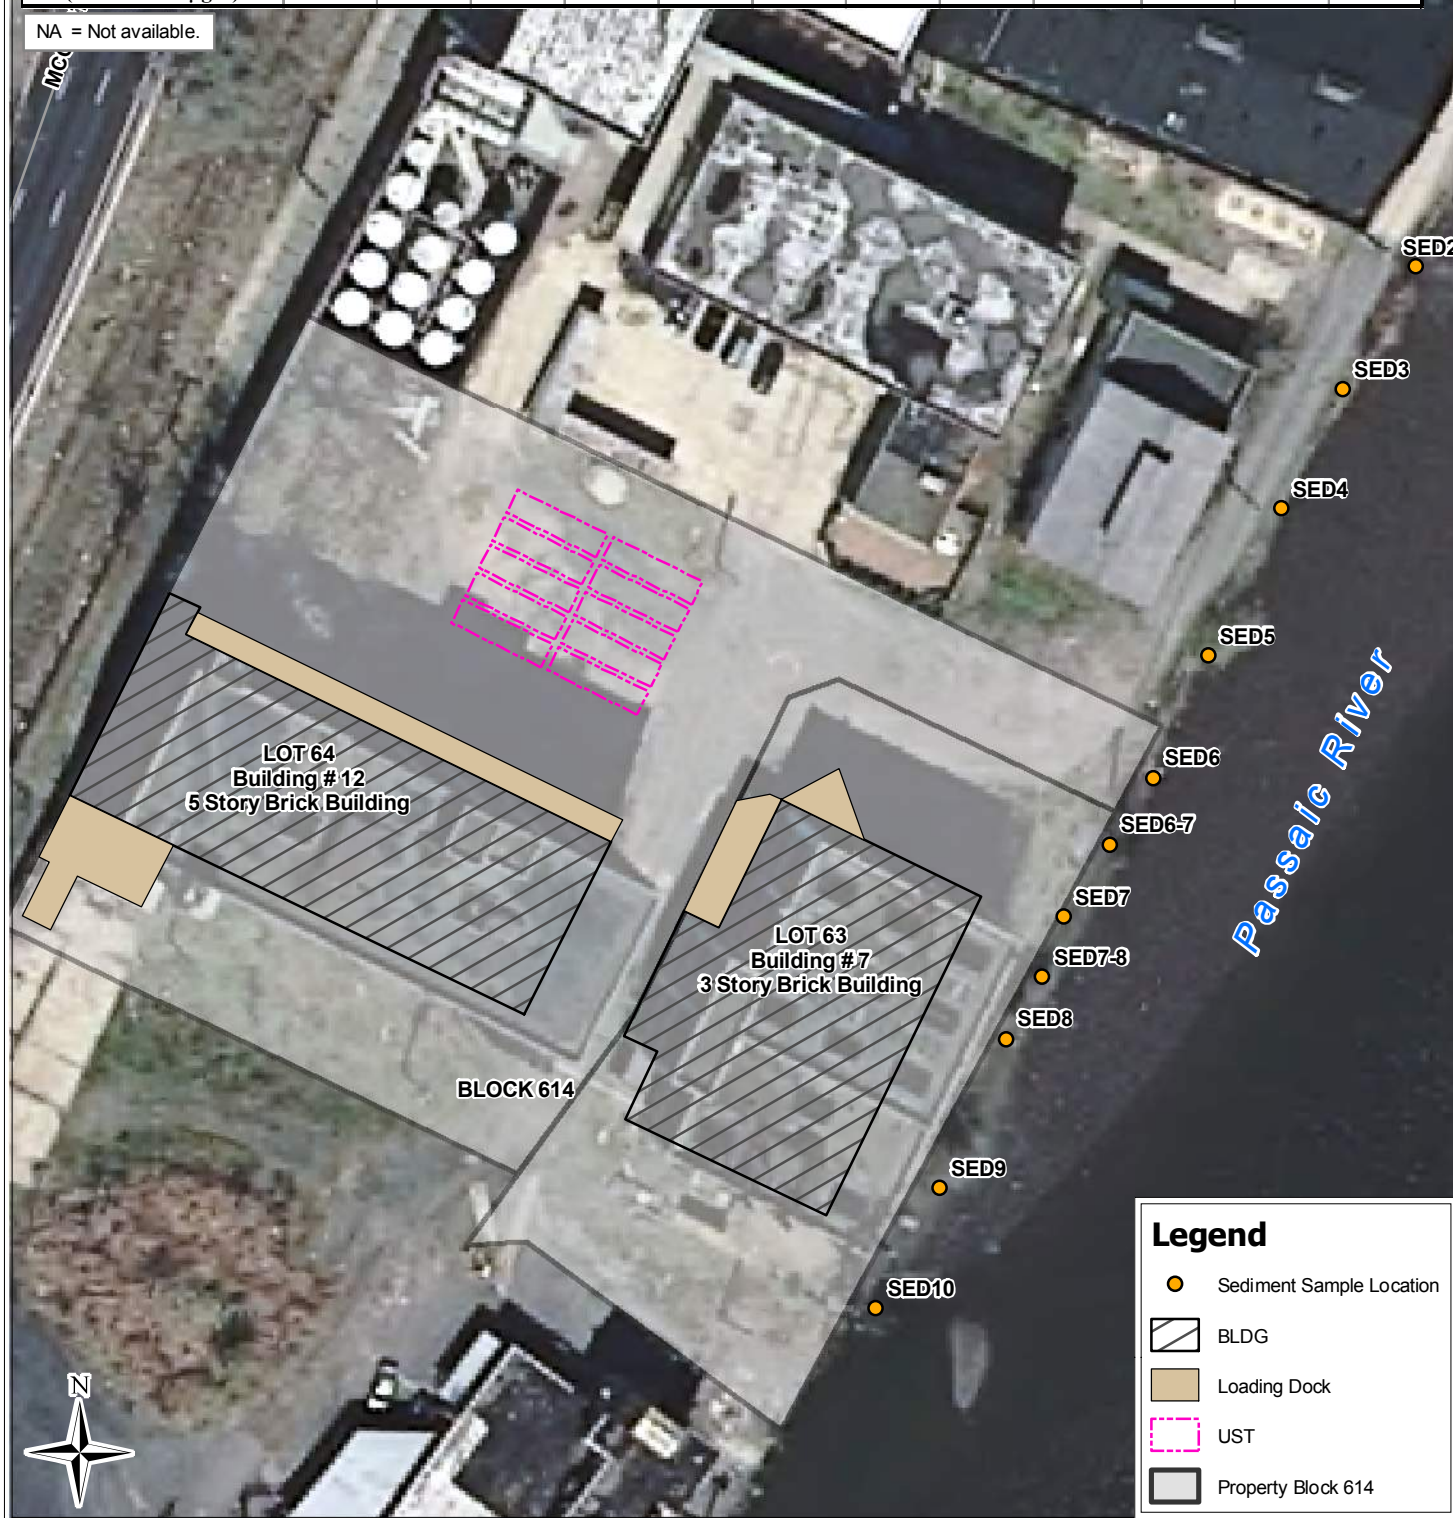
Figure 4
Lead Results in Sediment and Sediment Porewater
29 Riverside Ave. (Phase 2 Assessment)
Newark, New Jersey

Legend

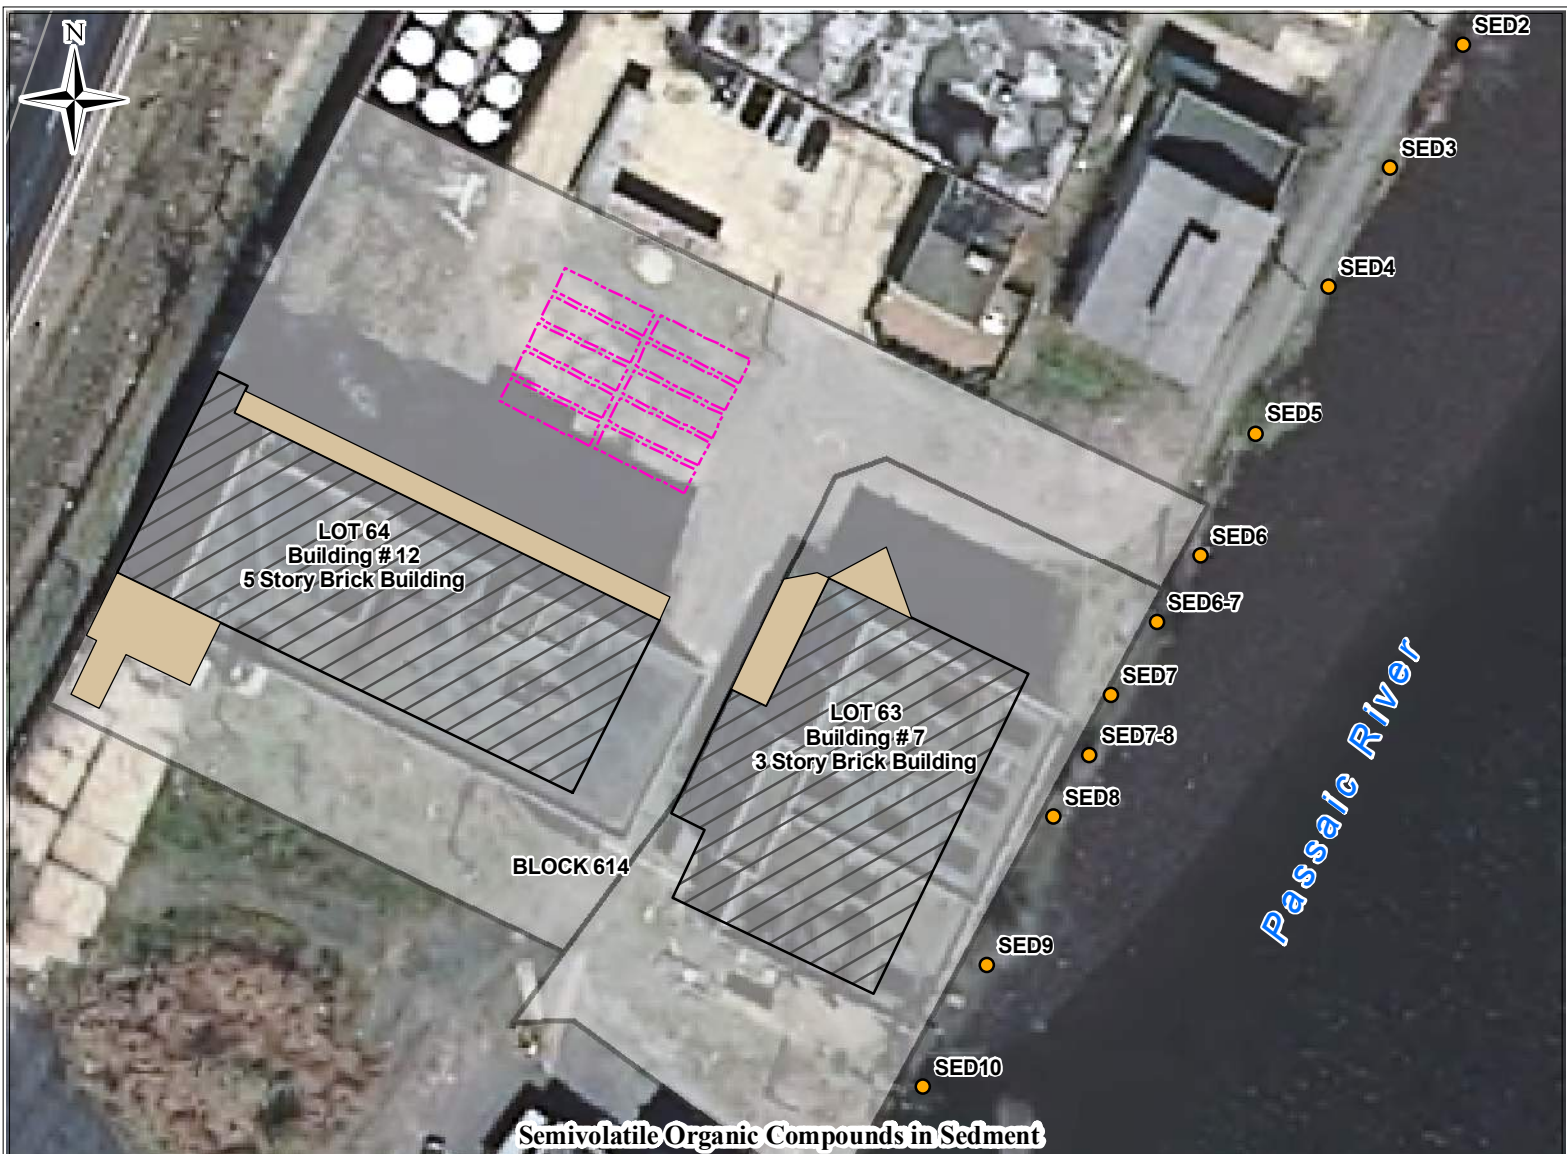
Analyses of lead from sediment were compared to the NRDCSCC, which is 600 mg/kg (Table 5). All of the sediment samples, except SED10, contained lead concentrations exceeding the criteria with the highest concentration of 940 mg/kg identified at SED9. Lead concentrations in the porewater were compared to the SGWQC of 5 µg/L (Table 5). All ten samples contained lead exceeding the criteria with concentrations ranging from 86 to 1,100 µg/L. The analytical results are provided on Figure 4.

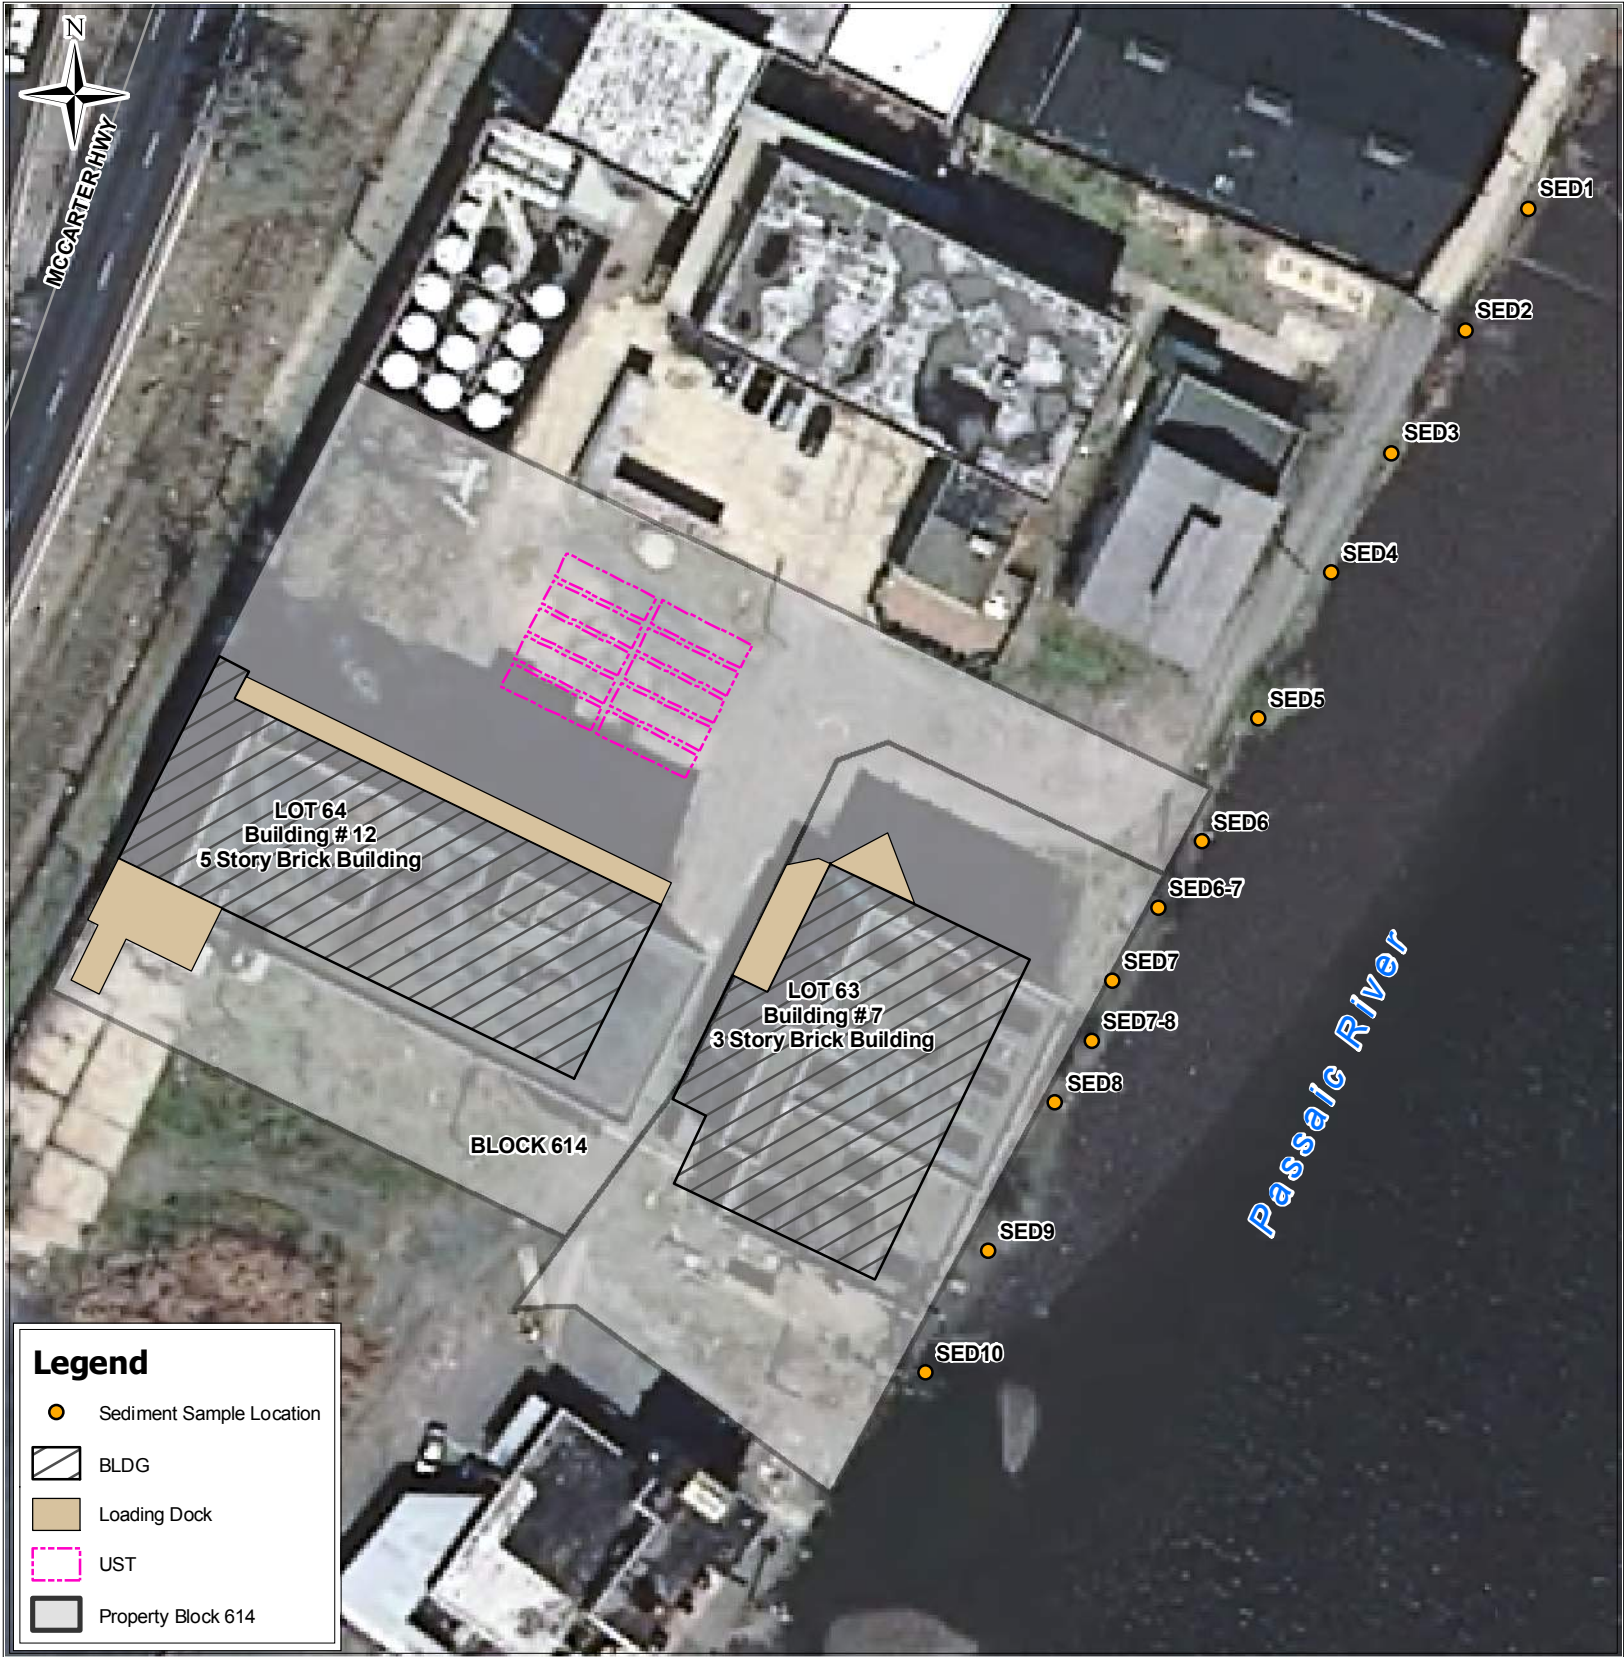
Figure 6
VOC & SVOC Results In Sediment Porewater
29 Riverside Ave. (Phase 2 Assessment)
Newark, New Jersey

Map created using 2007 orthoimagery from NJGIN, site survey GPS data, sample results data.
